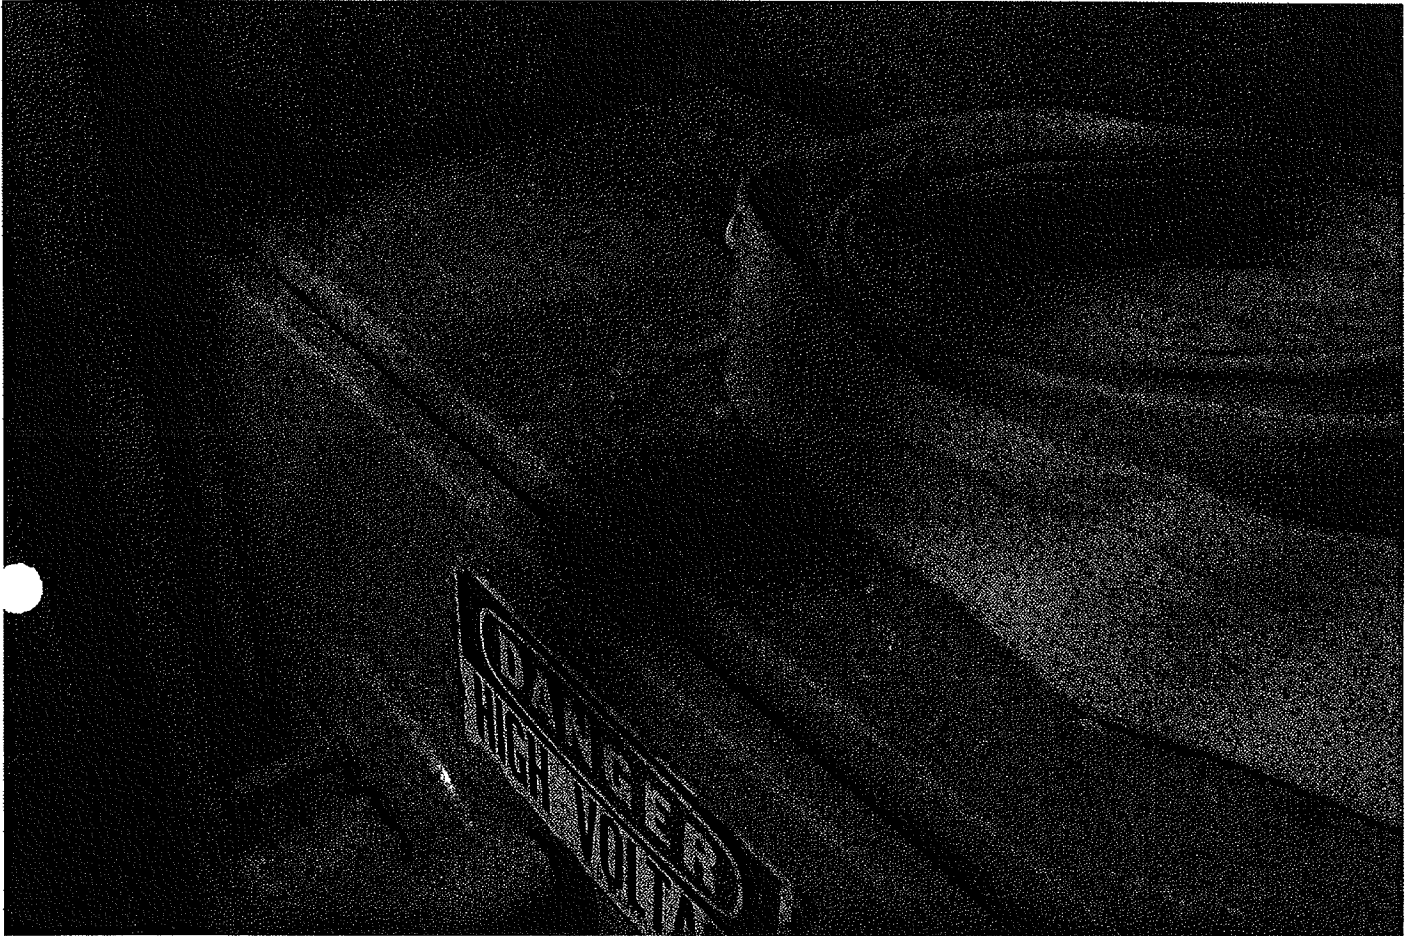
41. B Floor East Mech Rm - View of fireproofing debris on top of breaker box

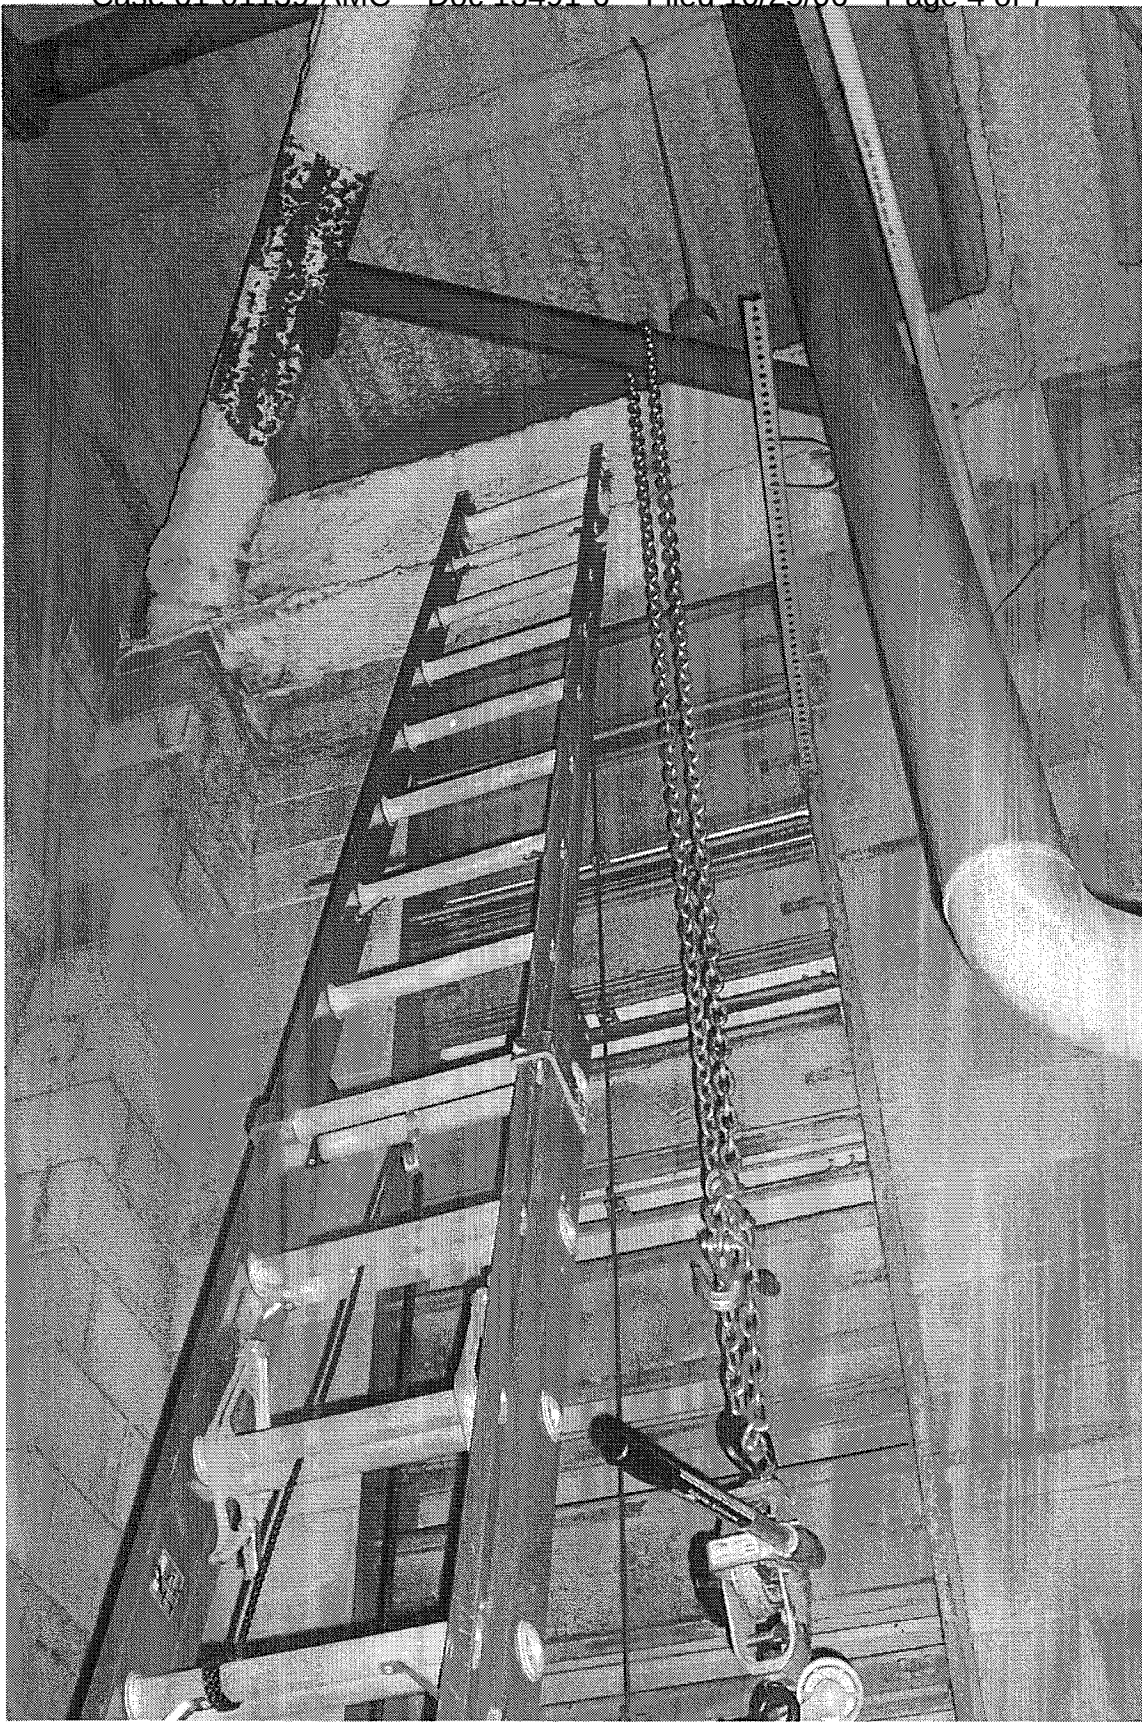
43. B Floor East Mech Rm - View of ladder above breaker box

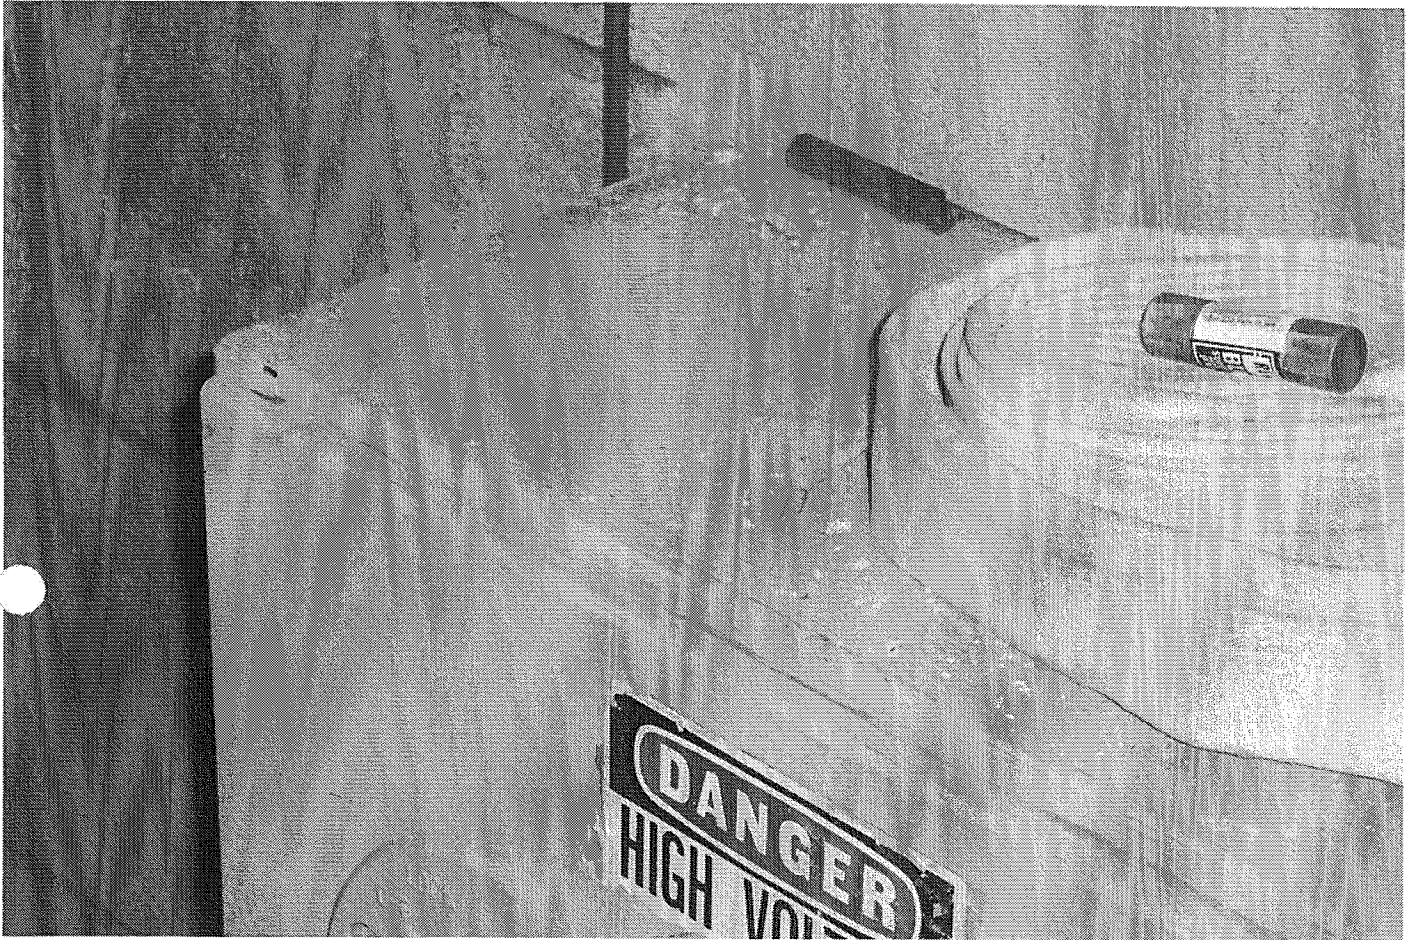
45. B Floor East Mech Rm - Location of sample #2 - top of breaker box

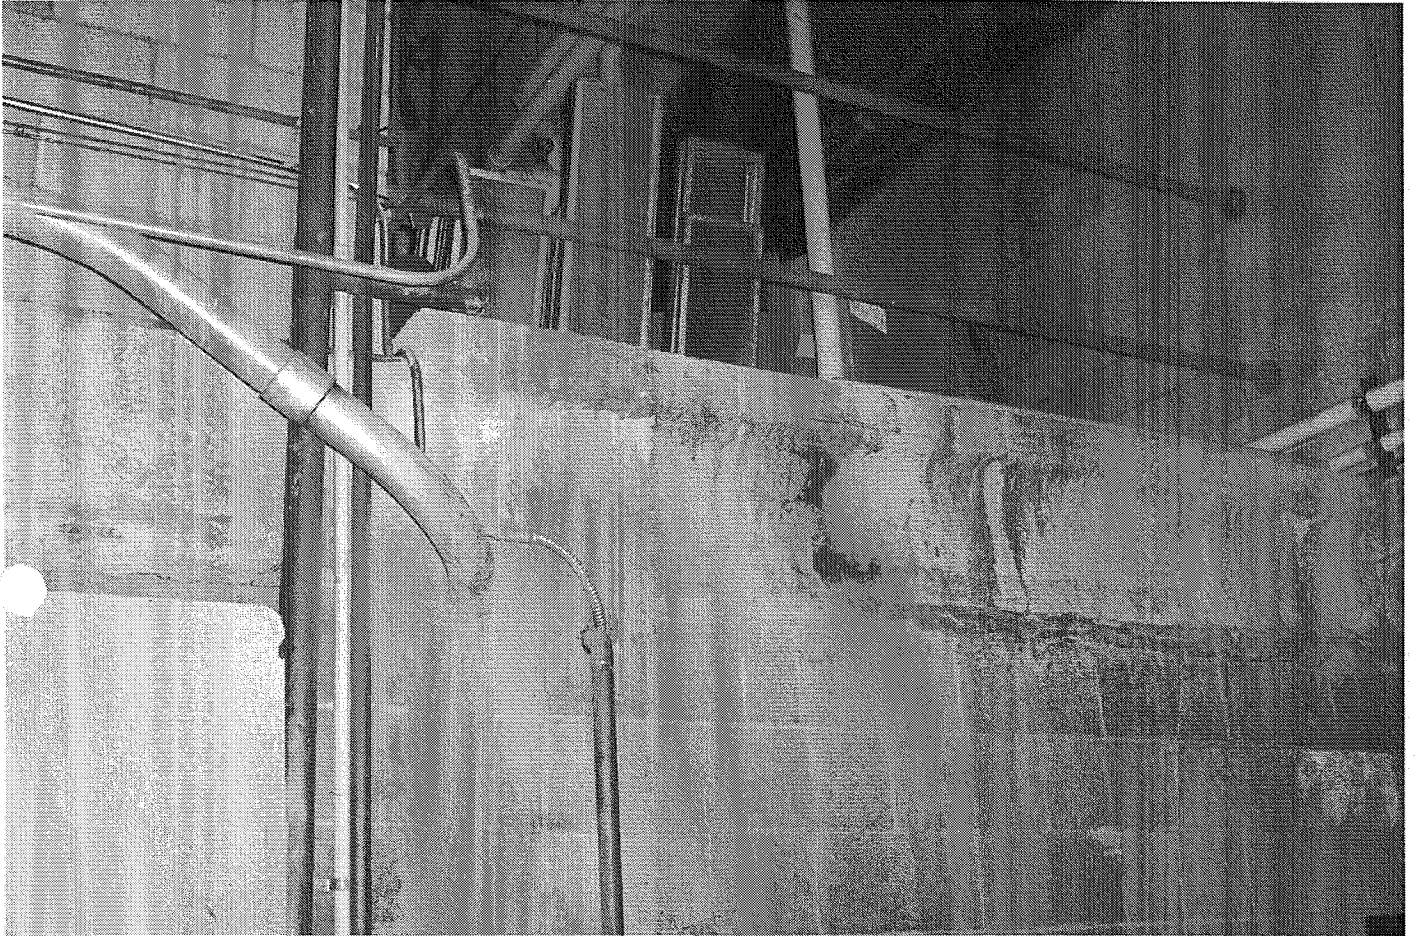
46. B Floor East Mech Rm - Damaged fireproofing on exposed I-beam
